TRAFFICABILITY TESTS WITH THE
MARSH SCREW AMPHIBIAN ON
COARSE-GRAINED AND FINE-GRAINED SOILS

TECHNICAL REPORT NO. 3-641

January 1964

U. S. Army Engineer Waterways Experiment Station
CORPS OF ENGINEERS
Vicksburg, Mississippi

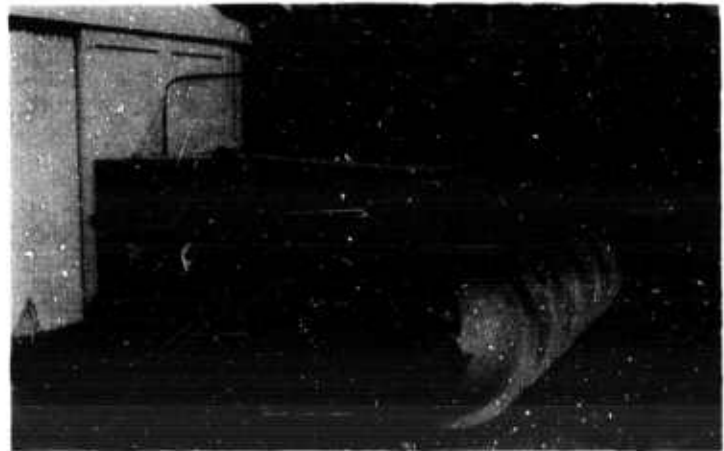
Fig. 1. Marsh Screw Amphibian (front view)

7. The Marsh Screw's unusual concept of locomotion places it outside the normal tracked and wheeled vehicle classifications. "The vehicle's name is the best possible, three-word description. Marsh is the area in which it is designed to operate and the area [in] which it performs best. The word Screw describes the method of propulsion, which is based on the Archimedean screw, two of which are used. Amphibian is the general vehicle classification because the vehicle will run on water, marsh, and on many land conditions."* Features of the vehicle are shown in figs. 1 and 2.

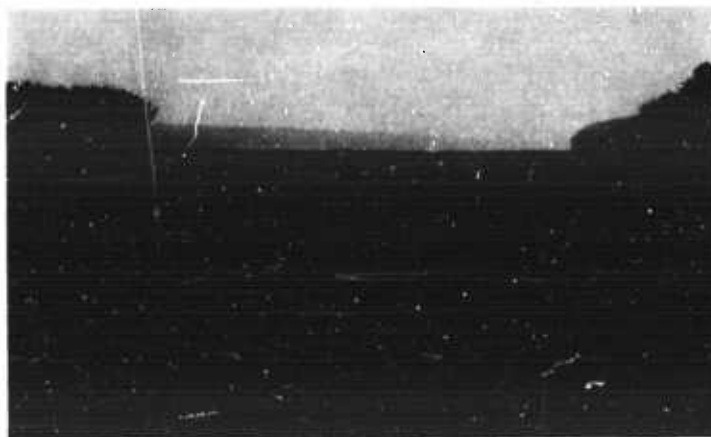
Fig. 4. Albemarle Lake test area

lies in an old channel of the Mississippi River and is still connected to the present river; therefore, the lake level fluctuates as the Mississippi River rises and falls. Tests were conducted on the fairly flat perimeter of the lake during a period of low-water level (see fig. 4). Most of the

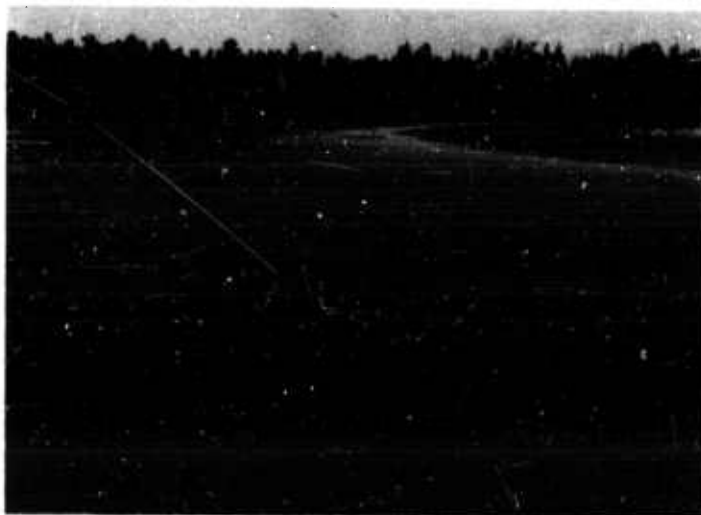
Fig. 5. Centennial Lake test area

area was covered with grass 2 to 5 ft tall; however, areas near the water's edge were devoid of vegetation. The soil in the area classified as fat clay (CH). A progressive decrease in moisture content with distance from the water's edge permitted testing on a wide range of soil moisture and strength conditions.

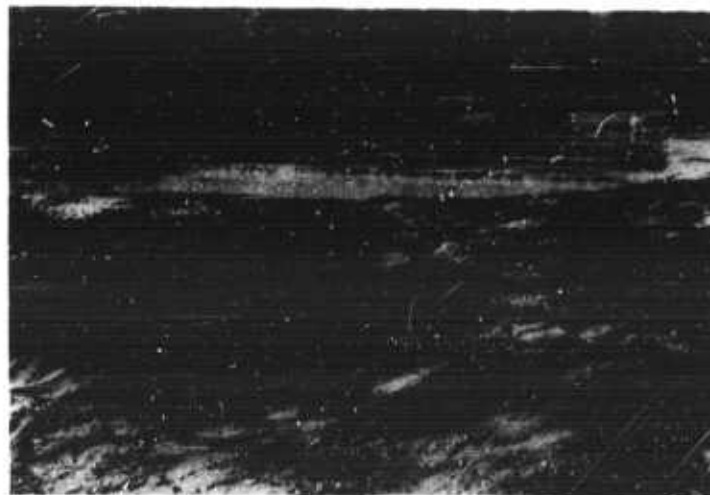
Fig. 6. Simulated rice-field test area

17. Simulated rice field. Fig. 6 shows a

simulated rice field with four dikes of varying dimensions in a bottomland silt (ML) area. Spaces between the dikes were flooded with water to a depth of approximately 8 in. The dikes were stabilized with cement so that they would retain their shapes after water was applied. The cone index of the soil in the dikes was greater than 300.

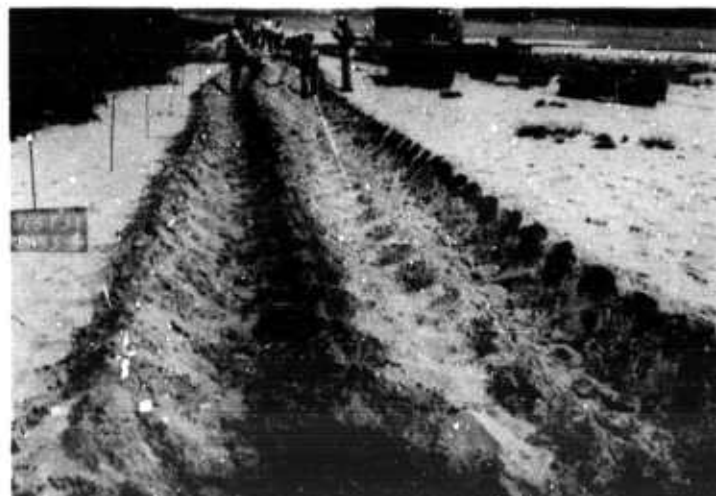
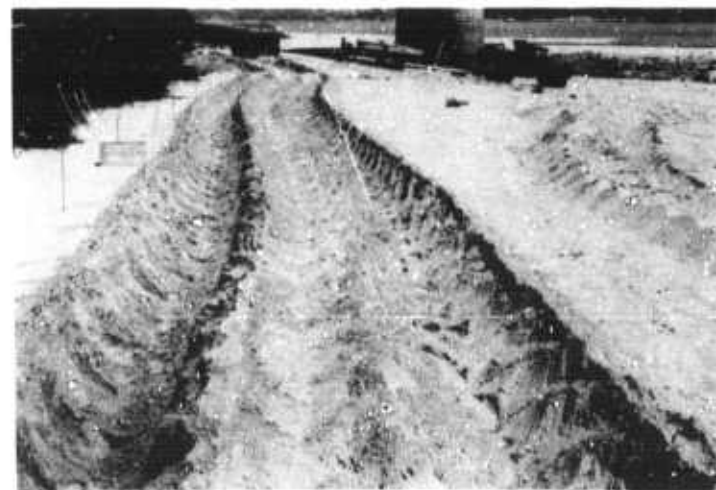
39. In the two tests at 2860 lb (tests 39 and 57), the operator experienced difficulty in keeping the vehicle in the test lane for the first few passes; however, after ruts about 6 in. deep had been developed the vehicle had no great difficulty following the same track on each pass. The action of the unloaded Marsh Screw on level sand can be illustrated by a series of photographs made for test 39. In this test, the 0- to 6-in. cone index was 60. Fig. 12 shows the test area prior to the test. Fig. 13 shows the path left after one pass of the vehicle; the ruts are about 5.6 in. deep. The average speed on the first pass was about 1 mph. Since the vehicle was at full throttle, this may be considered a maximum speed. Considerable difficulty was experienced on the first pass in keeping the vehicle in a straight line; it was necessary for the driver to steer continuously. Finally after a series of short, abrupt steering actions, the vehicle could not continue to turn its rotors and move forward. At this point, the vehicle was put in reverse and the test was continued. Fig. 14 shows the test lane after 5 vehicle passes; ruts were about 7.8 in. deep. Fig. 15 shows the path left after 20 passes. Note the curves in the test

Fig. 12. Test 39, before traffic

Fig. 13. Test 39,
after 1 pass

Fig. 14. Test 39,
after 5 passes

Fig. 15. Test 39,
after 20 passes

lane, which indicate difficulty in steering. The ruts were about 8.6 in. deep. At the end of 50 passes, the ruts were somewhat shallower, about 7.9 in. deep. In a similar test (57), on a cone index of 58 in the top 6-in. sand layer, the vehicle performed similarly except that it was not immobilized on the first pass, as had happened in test 39.

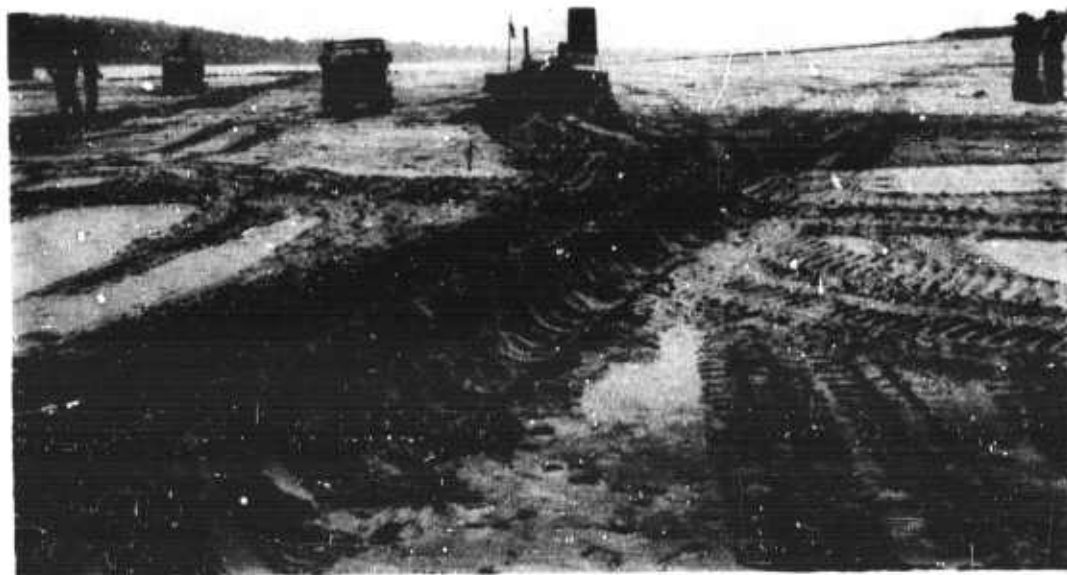
45. Two attempts were made to conduct maneuver-speed tests over courses about 300 ft long marked with stakes at 30-ft (test 58) and 50-ft (test 61) intervals. The vehicle did not complete either test because it became immobilized in trying to maneuver between the first two stakes. Data for these tests are not shown in the tables, but cone index of the 0- to 6-in. layer averaged 76. Fig. 16 shows the Marsh Screw immobilized

Fig. 16. Marsh Screw immobilized between first two stakes in maneuver-speed test 61

between the first and second stakes in test 61. The ruts in the foreground show the approach to the beginning of the test course.

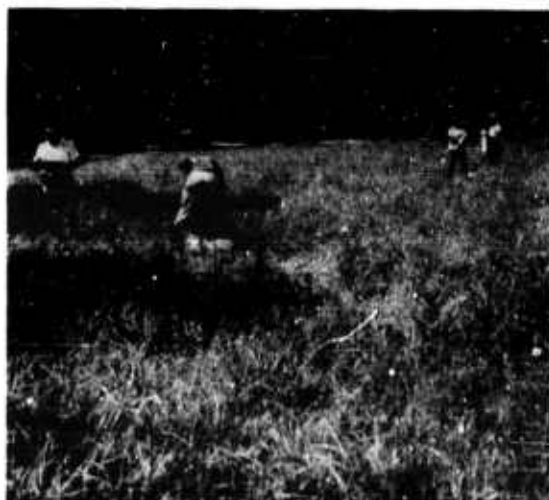
55. The soil in test 1 was the firmest in this series of tests. A view of the actual test site before traffic, with personnel measuring

Fig. 17. Site of test 1 at Albemarle Lake. Personnel are taking cone index measurements before traffic

before-traffic data, is shown in fig. 17. Note the high grass. Although not visible, shallow water stood in small surface depressions, such as those left by cattle hooves. Fig. 18 shows the path left by one pass of the Marsh Screw. The grass in the path has been pressed down, and rather definite traces of the Marsh Screw's helix can be seen; however, the path is poorly defined and ruts are obviously shallow. In fig. 19 the vehicle is shown on its seventh pass. Ruts remain shallow (1.5 in.).

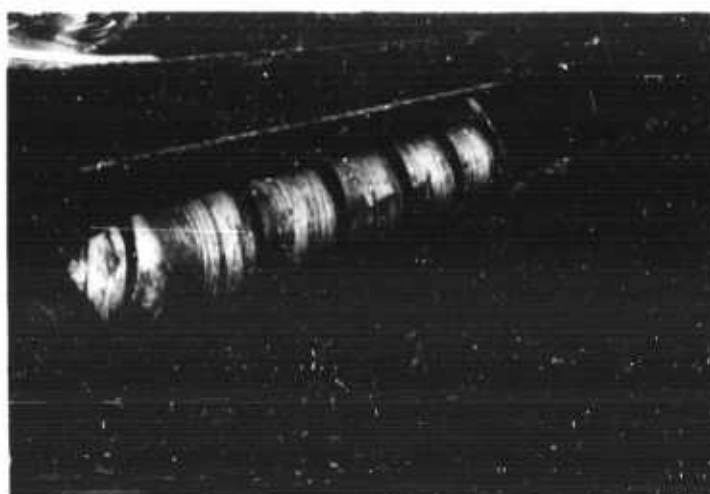
Fig. 19. Vehicle on 7th pass in test 1

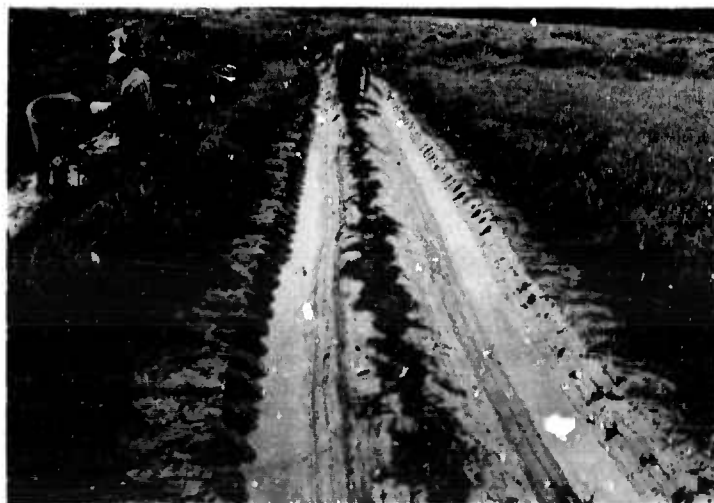
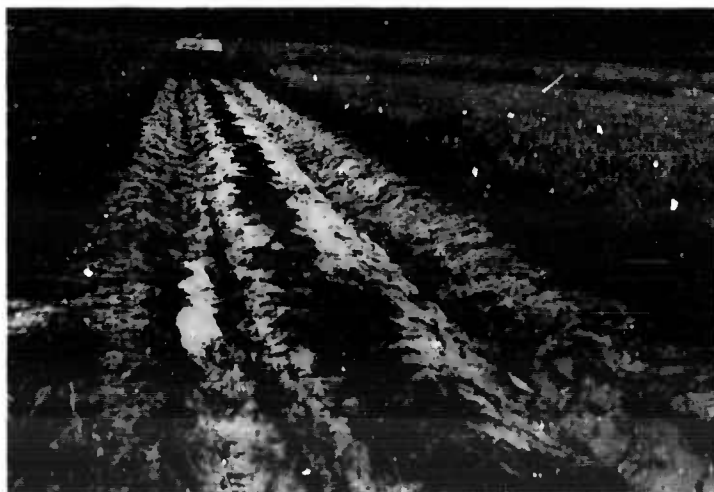
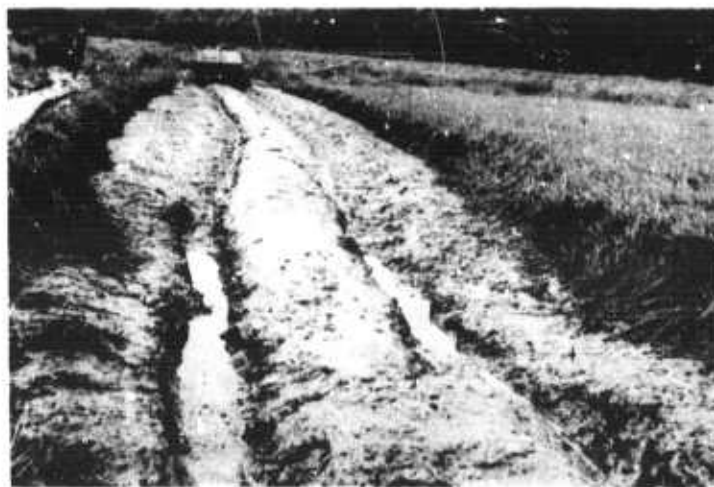
56. Test 35 is typical of the four "go" tests on a very soft soil condition. On the first pass, deep rutting occurred (see fig. 22). Note that the soil has flowed in both directions away from each rut, that the bottom of the Marsh Screw has flattened the grass between the ruts, and that there is considerable standing water in the ruts. Fig. 23 shows the appearance of the test lane as the Marsh Screw began its 11th pass. Fig. 24 shows the condition of the test lane after 50 passes.

Fig. 22. Test lane of
test 35 at Albemarle
Lake site after 1 pass

Fig. 23. Test lane
of test 35 after
10 passes

Fig. 24. Test lane
of test 35 after
50 passes

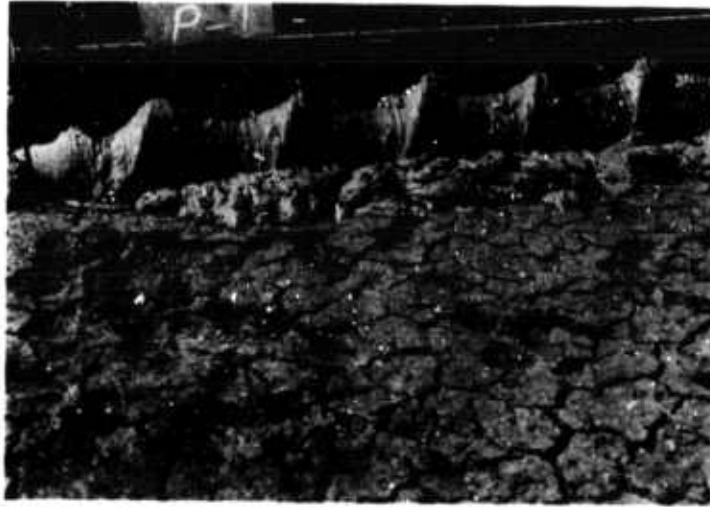
66. In test 72, the vehicle veered from the delineated test line toward softer soil and became immobilized because of high sinkage and a bulldozing action in soil that was soft (RCI = 6) and sticky. Fig. 33 shows the vehicle in the immobilized status. Note the complete coverage

Fig. 33. Vehicle immobilized on 1st pass in test 72 at Centennial Lake

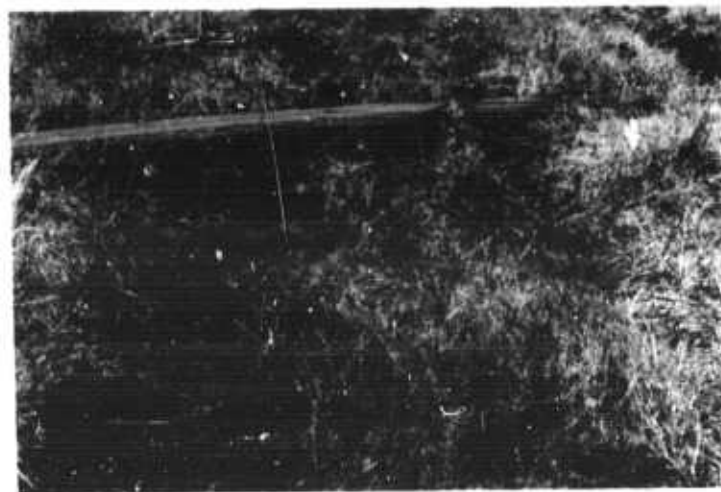
76. Test 100 was run on firmer soil than were the other two tests. The soil conditions in test 98, which were about the same as those of test 99, are illustrated in figs. 40-43. A maximum speed of approximately 5 mph was attained on the lowest rating cone index (about 10). The speed decreased rapidly to about 2 mph on an RCI of approximately 20, and remained fairly constant thereafter.

Fig. 40. Test 98;
straight-line speed
test course at Albe-
marle Lake; sta 3+50
in foreground

Fig. 41. Test 98; be-
ginning of straight-line
speed test course

Fig. 42. Test 98; mid-
dle of straight-line
speed test course

Fig. 43. Test 98; end
of straight-line speed
test course

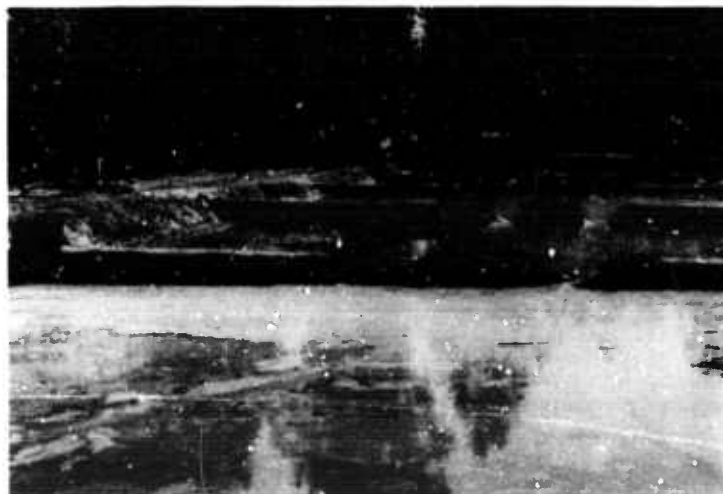
Fig. 45. All four rice-
field dikes after traf-
fic of Marsh Screw;
dike 4 in foreground

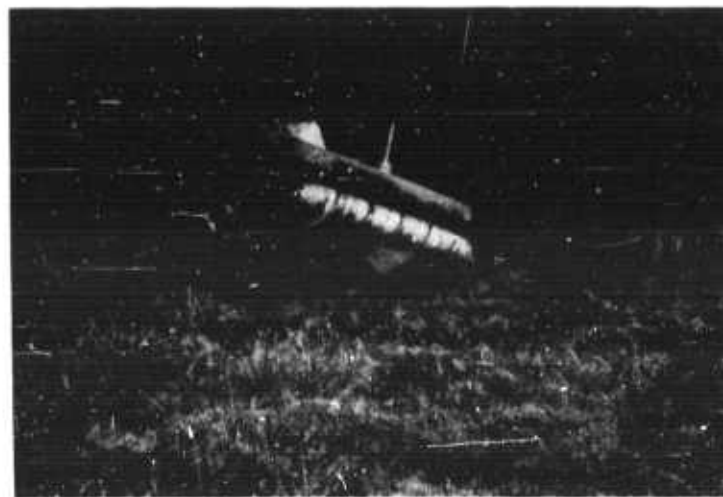
Fig. 46. Marsh Screw
climbing soft, wet
earth mound at Albe-
marle Lake

the firm, stabilized dikes of the simulated rice field was generally considered poor, the vehicle could climb 3-ft-high, wide-based, soft mounds of wet earth (at Albemarle Lake) with little difficulty.

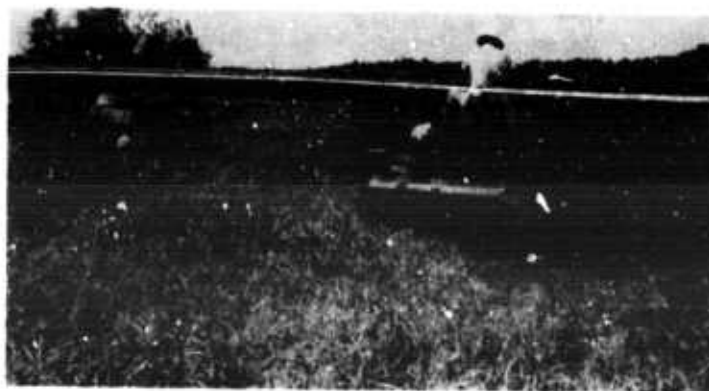
Fig. 47. Test 28, maximum towing force test on grass-covered soil at Albemarle Lake

Fig. 48. Test 76, maximum towing force test on bare soil at Centennial Lake

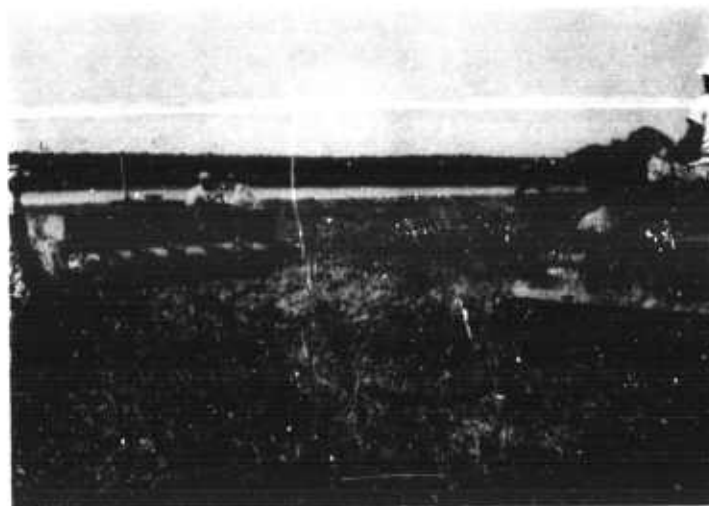
Fig. 49. Marsh Screw towing laterally

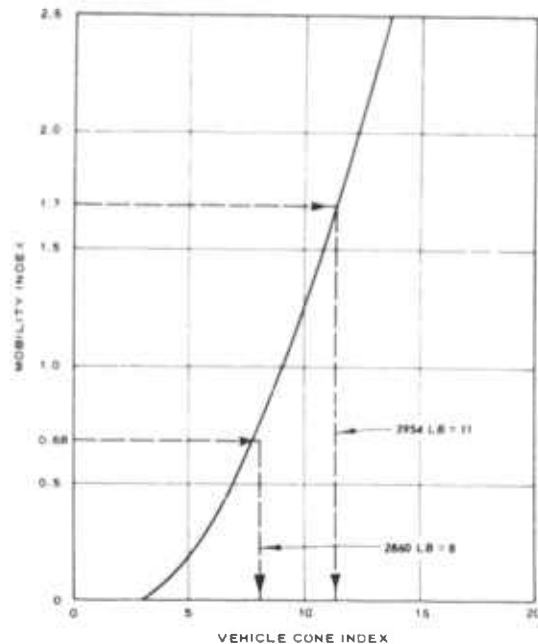
Fig. A1

4. The VCI is obtained from a curve of MI versus VCI (fig. A1). It

can be seen that the Marsh Screw has a VCI of 8 (at 2860 lb) and 11 (at 3954 lb), assuming the vehicle factors mentioned in the preceding paragraph. Since the experimental VCI was determined to be 5 from the tests at Albemarle Lake, it must be recognized that the tracked vehicle formula permits computation of only an approximate value of RCI for the Marsh Screw.

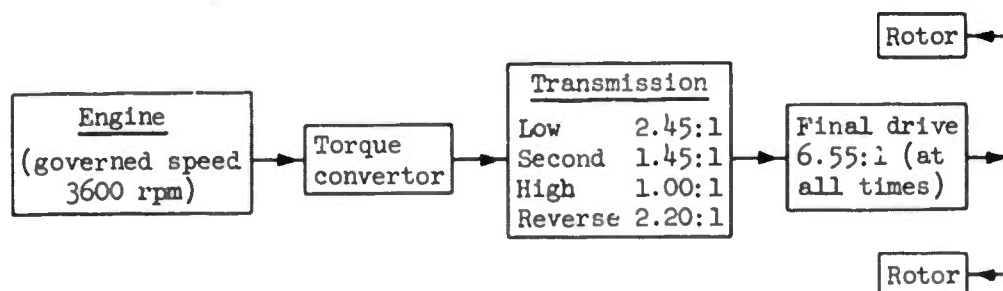
Fig. B1

2. Power is transmitted from the engine through a torque convertor and transmission to a final chain drive connected to each rotor. A schematic flow chart of the power system is shown in fig. B1.

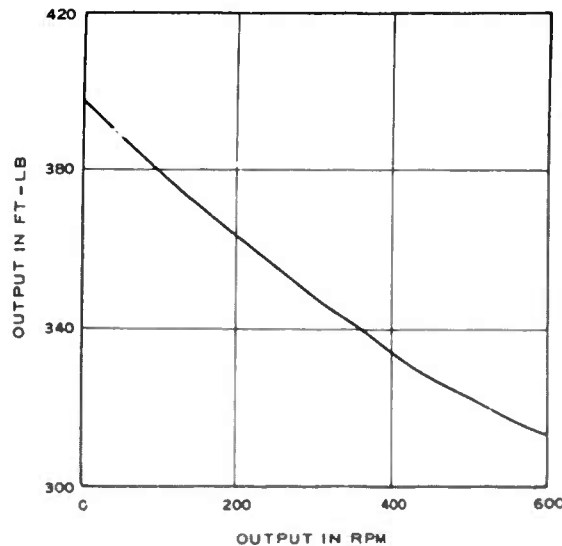
- a. Assume the engine to be running at full throttle (not necessarily full revolutions per minute). If towing force is applied to the vehicle the torque convertor output in foot-pounds will increase but the torque convertor output in revolutions per minute will decrease; therefore, vehicle speed will decrease. Fig. B2 shows the relations between torque convertor output in foot-pounds and revolutions per minute.
- b. When vehicle speed is reduced from 1.5 to 0.5 mph, additional towing force (and horsepower) available may be computed by assuming zero slip of the rotors, zero power loss in the power train, and a constant coefficient of friction between rotors and soil regardless of vehicle speed.
- c. For each revolution of the rotors the vehicle moves 4 ft forward; therefore, at 1.5 mph the rotors turn at a rate of 33 rpm, and at 0.5 mph they turn at a rate of only 11 rpm.
